Investigations of Failures of Epoxy Polymer Overlays in Missouri

Prepared by
Missouri Department
of Transportation

RI06-020

November 2007

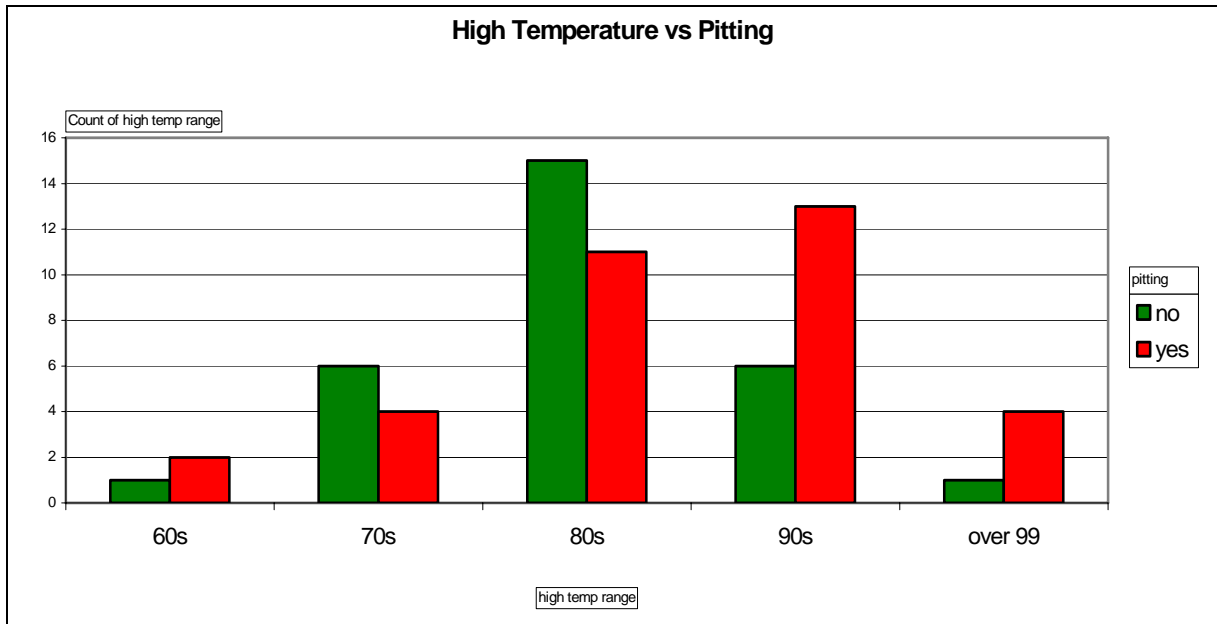
Figure 3. High Temperature at Placement vs. Pitting

An unexpected observation during the study was the presence of pitting on a majority of the bridge decks. Sixty-two out of ninety eight bridges had pitting of some degree. (The epoxy polymer overlay on two of the bridge decks, K108 placed in 1990 and A1944 placed in 1984, had worn to the point that determining failure mechanisms was impossible.) The degree of pitting ranged from pinprick sized pits to quarter inch sized pits. Pitting has been noted in many literature reports; however most sources claim that the pits will never line up between the two layers of overlay and should not be of concern. In the course of the investigation we found areas where the pits DID line up which create a funnel for water and chlorides to enter the deck. We also found that once the pitting became larger the EPO began to show signs of cracking between the pits, which eventually became block cracking. One source of pitting is the presence of air bubbles in the epoxy component of the overlay. In discussions with epoxy suppliers it was noted that the use of certain types of paddles for mixing can lead to air bubbles within the epoxy. The proper type of paddle to be used is called a “jiffy paddle” or a “Sika paddle.” Most epoxies have a maximum speed for the paddle, mixing any quicker can introduce air. Inspectors should verify that the contractor is using the correct type of paddle for mixing the epoxy and that the correct speed is being used. It was also noted that an increase in temperature leads to an increased chance of pitting. See Figure 3. During higher temperatures, extra care should be given to working out any remaining air bubbles during placement. The likelihood of pitting also increased with the number of freeze/thaw cycles. See Figure 4.

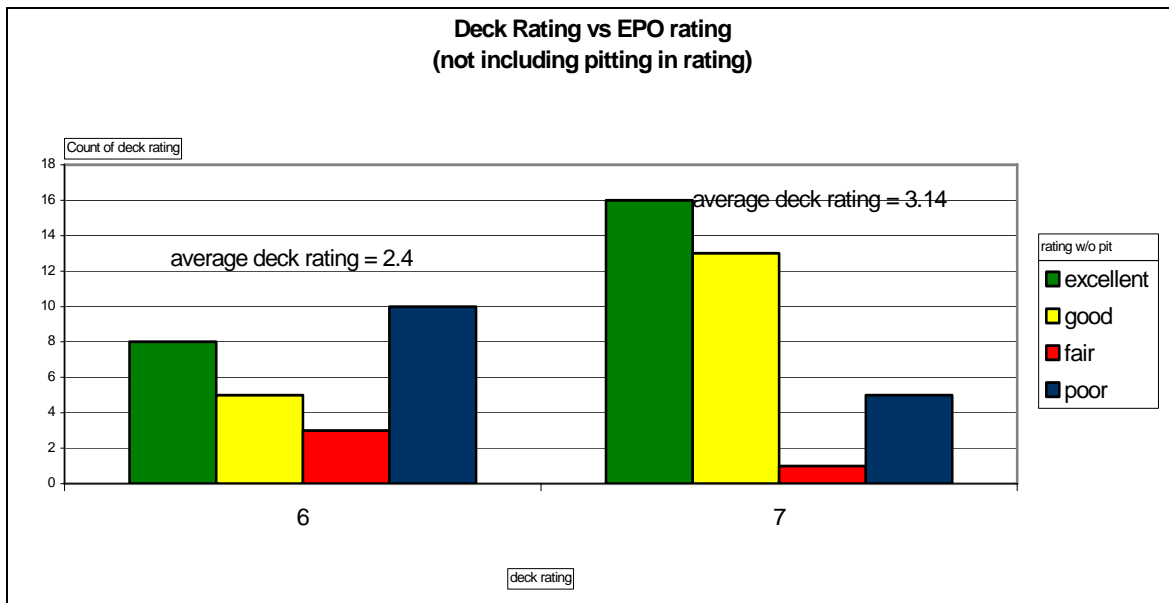
Figure 5. Previous Deck Rating vs. EPO Rating

For those bridges that we were able to gather background information, we collected the previous deck survey prior to placement. Most bridges had either a rating of 6 or 7. There were a few decks that were previously rated an 8 however there were only five. Four out of the five had overlays that ranged in age from 12-14 years old so there is not enough data to draw any conclusions for those bridges. In order to quantify the EPO rating, each bridge was given a number of the EPO rating of 4 for excellent down to 1 for poor. The average rating for the overlay on the bridges with a previous deck rating of 6 was a 2.4 whereas the average rating for the overlay on the bridges with a previous deck rating of 7 was a 3.14. See Figure 5. The bridge decks with a higher deck rating prior to placement are more likely to have an excellent or good rated overlay.

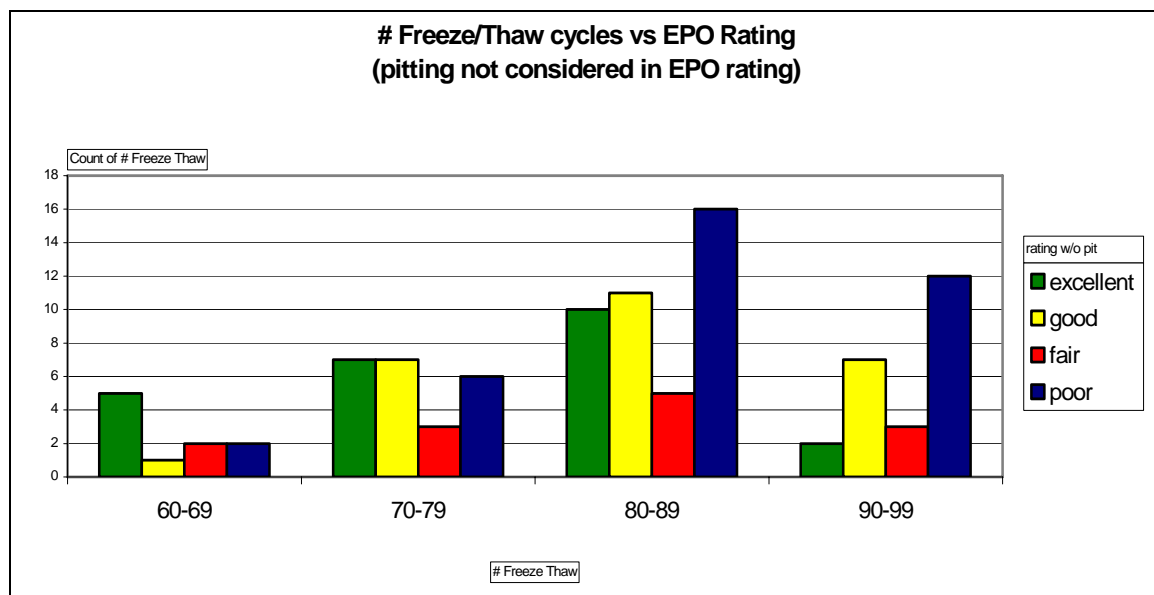
Figure 6. Freeze/Thaw Cycles vs. EPO rating

The number of freeze/thaw cycles greatly impacts a bridge deck. When water infiltrates the surface then freezes it can cause fractures in the concrete. The same can be said for epoxy polymer overlays, especially if the overlay has pitting. We gathered climatological data for each bridge deck. The Midwest Regional Climate Center provides the average values for temperatures from 1971 to 2000. By looking at the number of days below freezing and above freezing we estimated the number of freeze/thaw cycles at the nearest weather station to each bridge. As expected as the number of freeze/thaw cycles increases the average rating of the overlays decreased. See Figure 6.

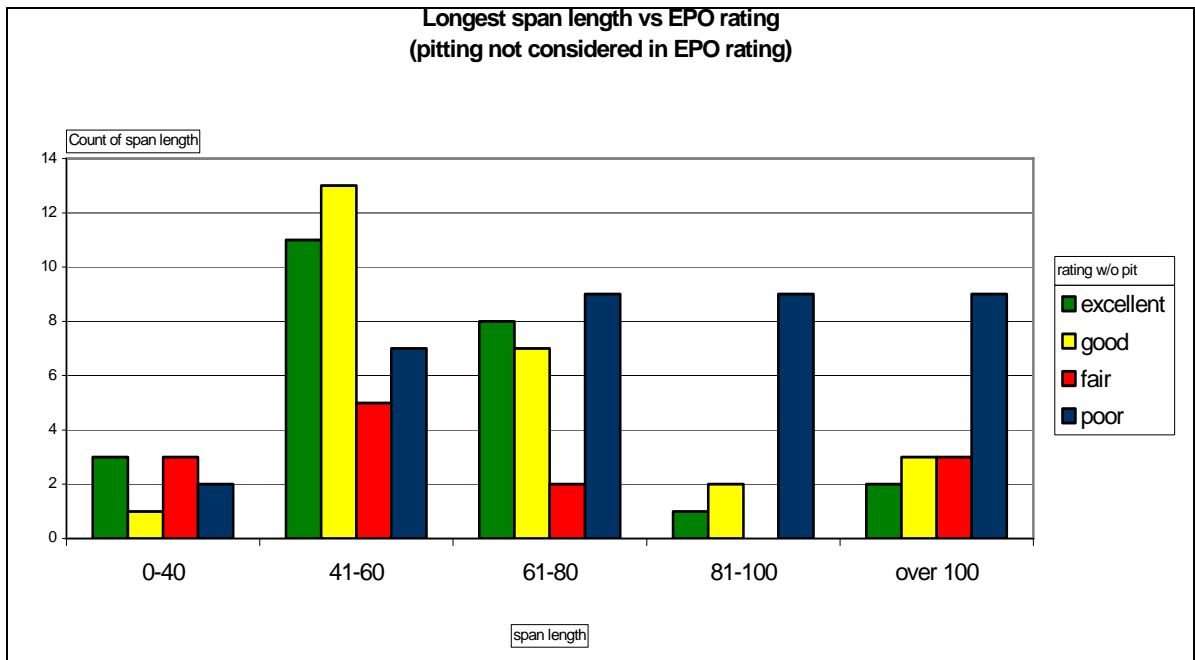
Figure 7. Longest Span vs. EPO rating

The span lengths of the bridge had an effect on the performance of the overlays. We compared the longest span length and overlay rating which indicated that the longer span bridges were more likely to have problems with their overlays. See Figure 7 and 8. This is not surprising since the longer spans will be more flexible, increasing the chance of the epoxy and/or deck cracking. Some of the newer epoxies are more flexible than the older epoxies, which should help with this problem. For bridges with long spans it would be more cost effective to look for an epoxy that is more flexible as opposed to going with the cheapest product. Transpo-T48 is a more flexible epoxy that might provide better protection on flexible decks. The girder type is related to the span length so the same pattern was found. Bridges with steel wide-flange sections and P/S I girders had higher EPO ratings than steel plate girders. See Figure 9.

- For bridges with long spans or flexible decks, require a flexible epoxy even if it is a little more expensive. A suggested brand is Transpo-T48.

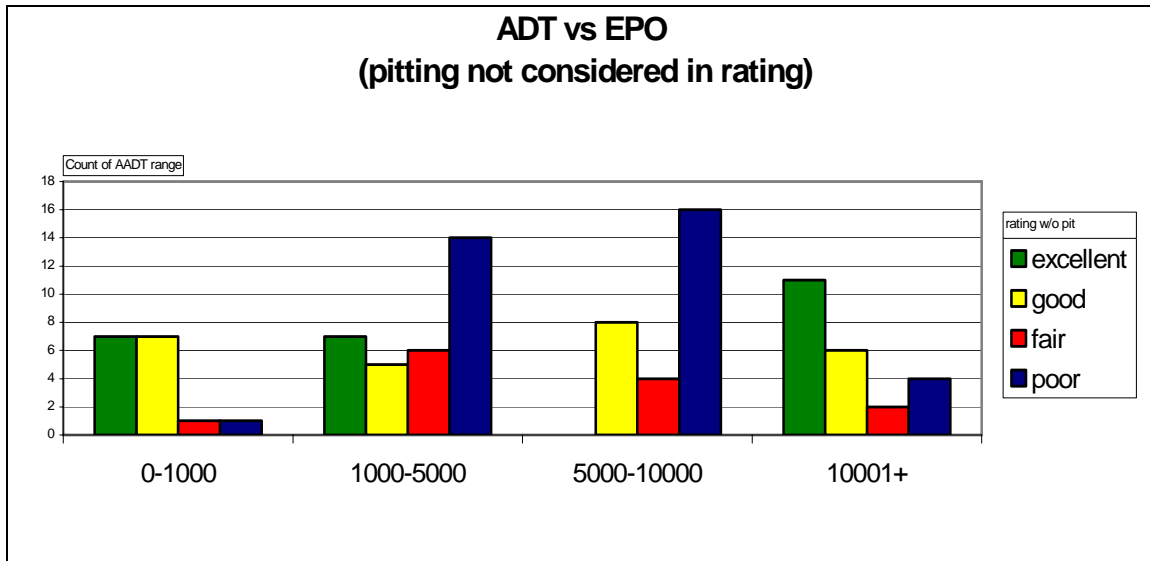
Figure 10. ADT vs. EPO

As expected when the number of cars and trucks that drive on an epoxy polymer overlay increases the overlay rating decreases. See Figure 10.
